Park Road West, Chester

Saturated Ground, Garden

ECO-90[™] Technical System Specification

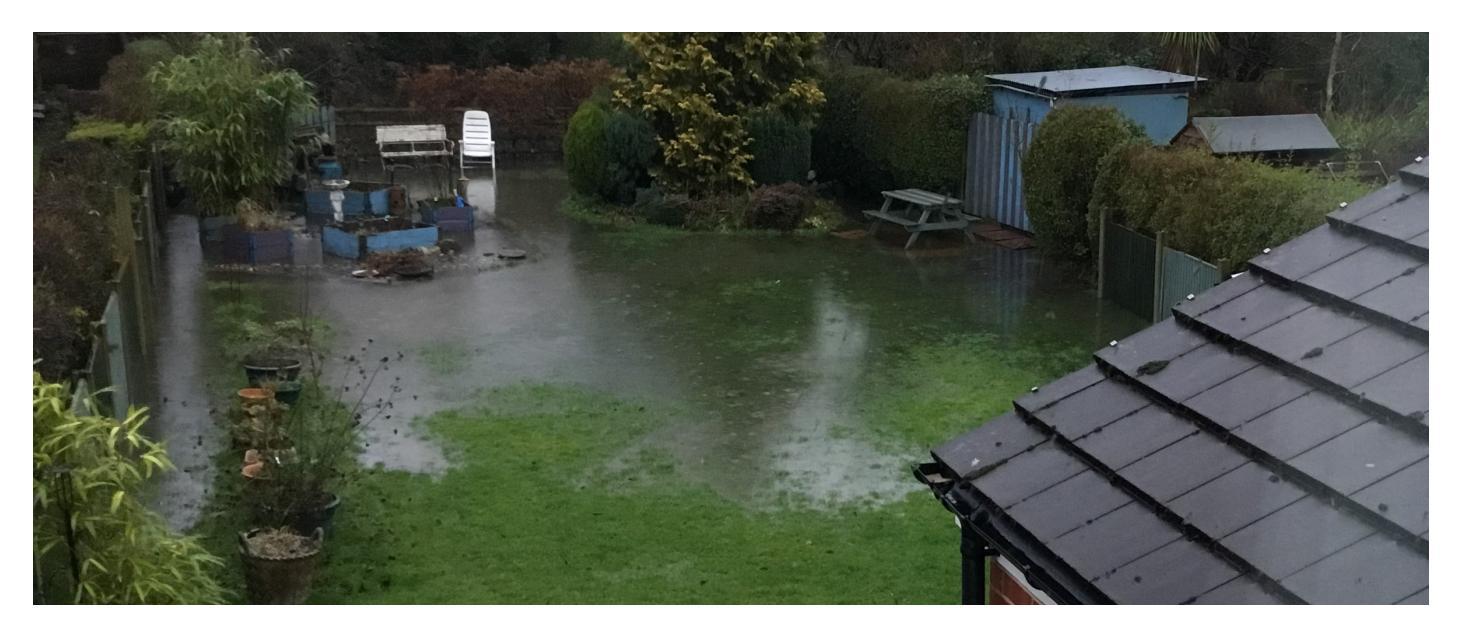
The property at Park Road West, Chester was suffering from severe flooding of the back garden throughout the wetter months of the year. The ground remained wet even through the summer. The owner not only wanted the garden back in use but was concerned as the situation had failed to rectify itself for over a decade. Local estate agents devalued the property by between 5%-10%, and were concerned that worries over flooding might make the property unsalable. To resolve the flood problem, we installed 24 primary ECO90s[™] beneath a 25m long buffer trench. Since installation, the area has remained dry, with the ECO-90[™] supported infiltration trench successfully discharging to sub-soils below the surface.

Project:	Alleviating flooding at the rear of the property via an ECO-90™ Supported Infiltration Trench
System design:	Infiltration Trench supported by ECO-90™ system
One trench:	Length 25m; Width 2m; Depth 0.8m; Max required capacity: 43.6m³
ECO-90™ system size¹:	24 number Primary ECO-90s™
Total ECO-90™ rod lengths:	658m
